TEST REPORT

REPORT NO.: 190703677RT

PRODUCT: Solar Grid-tied Inverter

STANDARDS: IEC 60068-2-1:2007; IEC 60068-2-2:2007; IEC 60068-2-14:2009; IEC 60068-2-30:2005

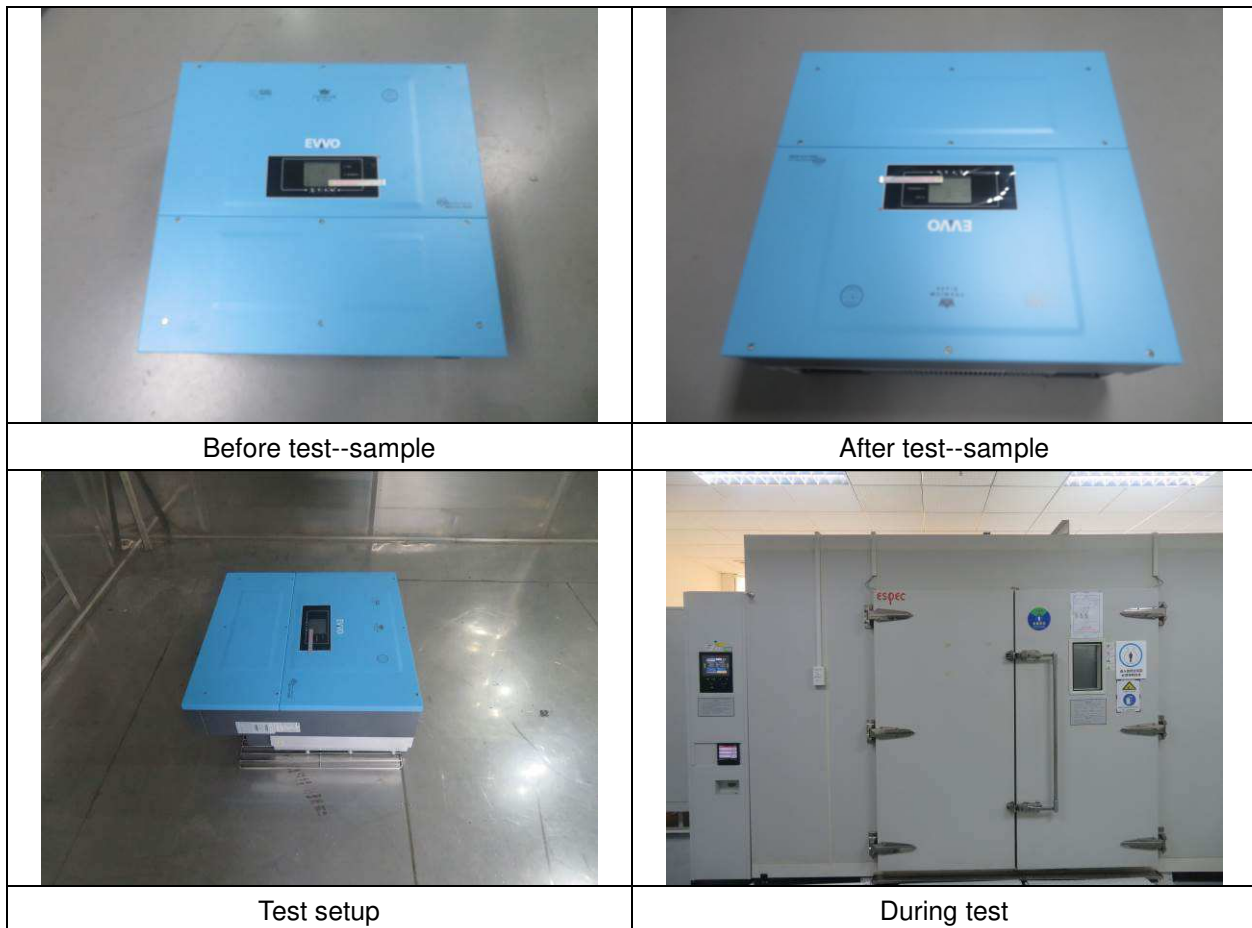
4.4 TEST PHOTO

Temperature: $(-25 \pm 2)^\circ\text{C}$

Rate of temperature change: $1^\circ\text{C}/\text{min}$

Test duration: 16h

| Sample No. | Test result |
|---|---|
| GZ190703/001-Q01N01GZ99 | After test, the sample no external physical damage. |

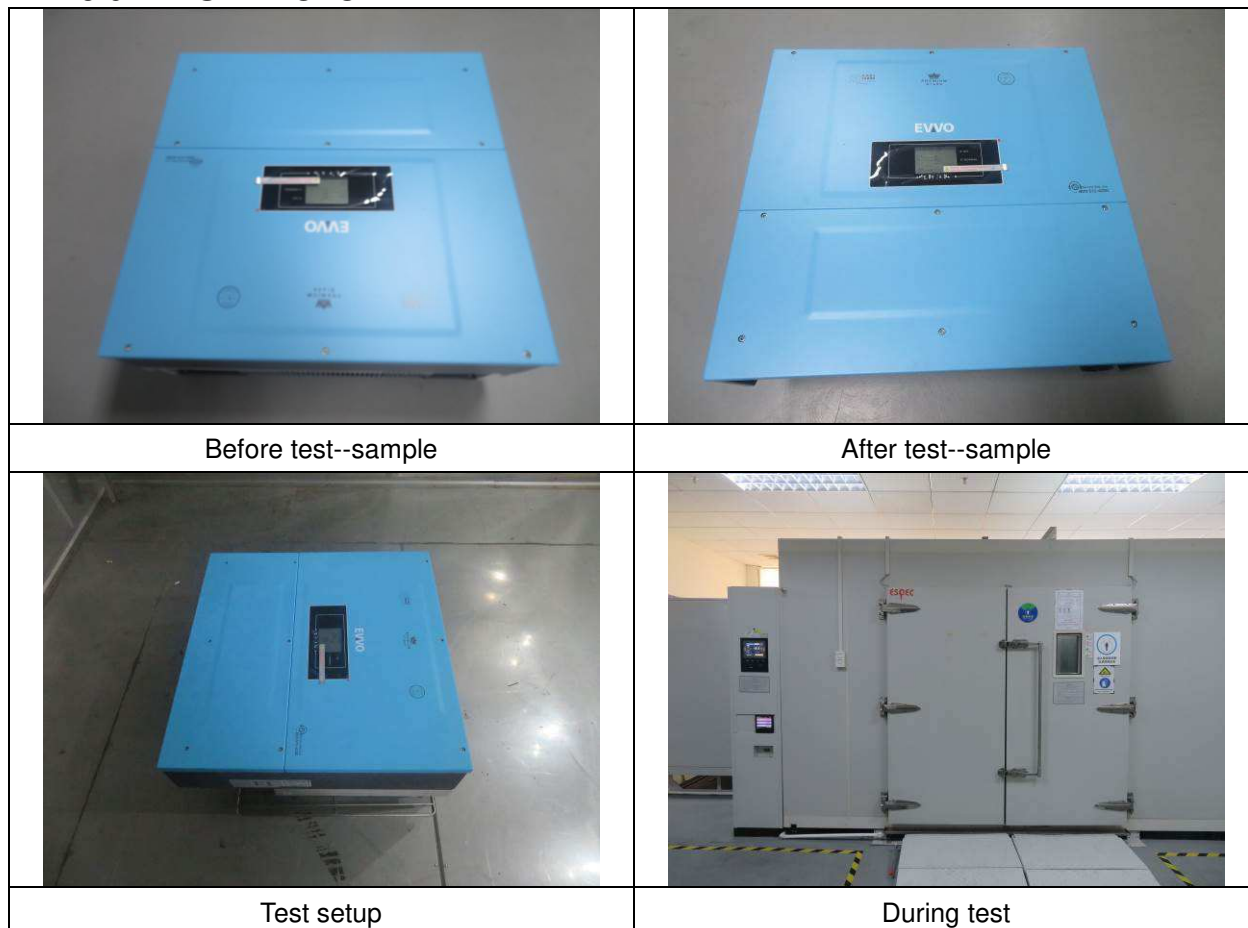
5.6 TEST PHOTO

Temperature:(60±2)°C

Rate of temperature change:1°C/min

Test duration: 16h

| Sample No. | Test result |
|---|---|
| GZ190703/001-Q01N01GZ99 | After test, the sample no external physical damage. |

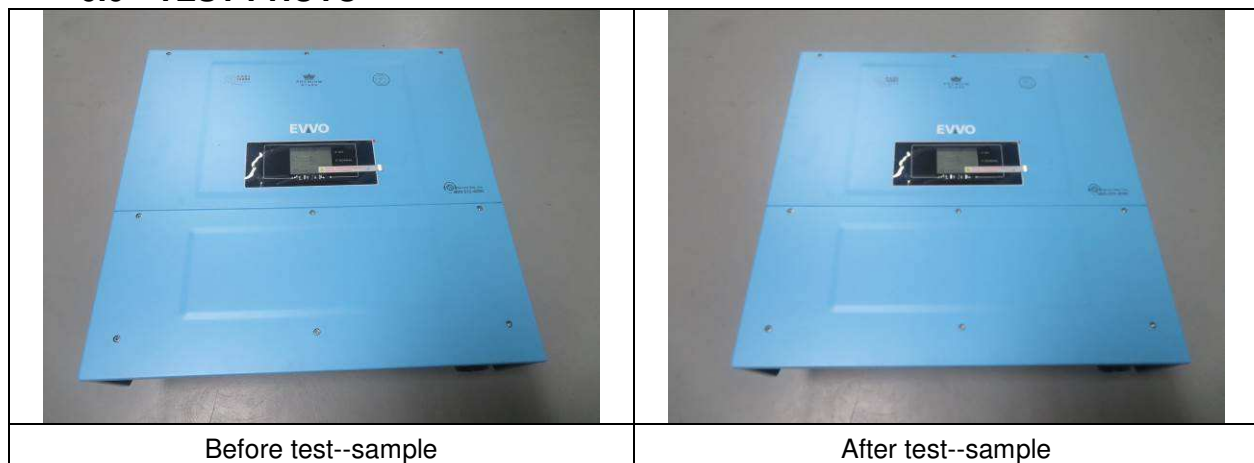
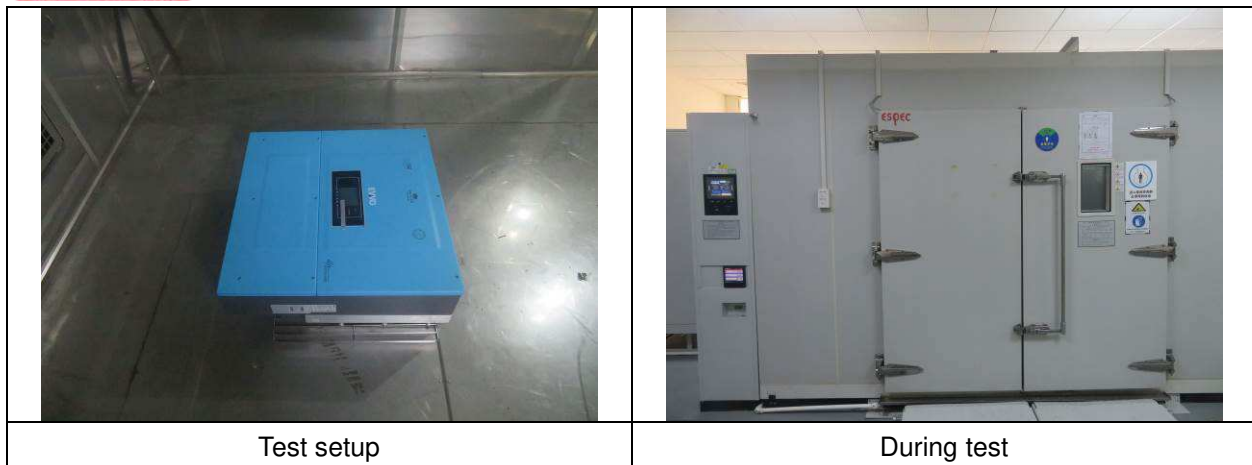
6.6 TEST PHOTO

Low temperature extreme: $(-25\pm 2)^{\circ}\text{C}$
 high temperature extreme: $(60\pm 2)^{\circ}\text{C}$
 Rate of temperature change: $1^{\circ}\text{C}/\text{min}$
 Dwell time: 3h for each temperature extremes
 Number of cycles: 1 cycle

| GZ190703/001-Q01N01GZ99 | After test, the sample no external physical damage. |

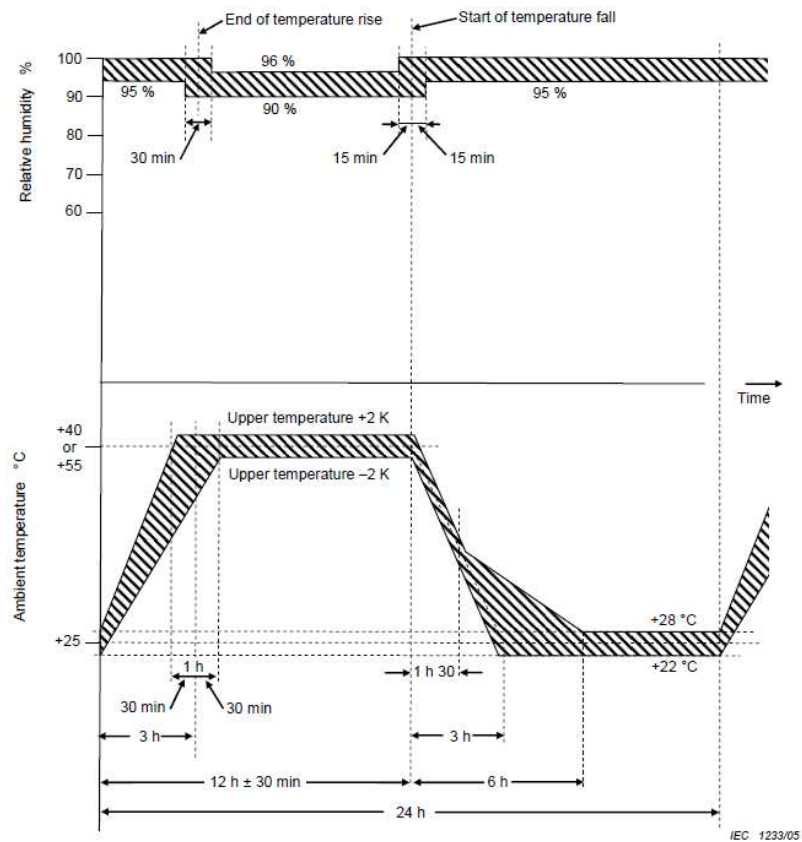
Figure 2a – Test Db – Test cycle – Variant 1

Temperature parameter and relative humidity according to figure 2a:

Upper temperature:55°C
 Number of cycles: 1

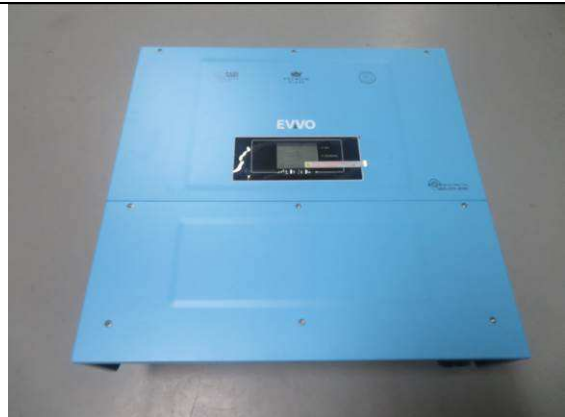
| <p>Before test--sample</p> | <p>After test--sample</p> |

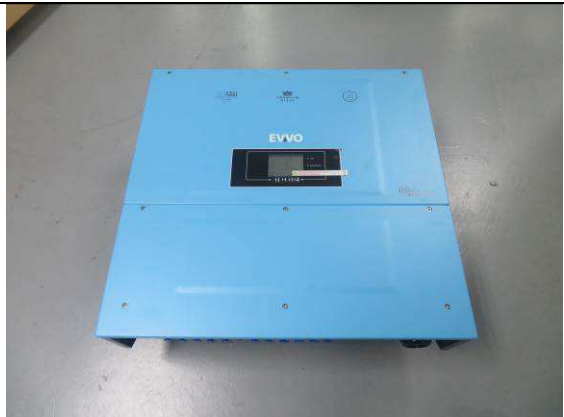
| Sample No. | Test result |
|---|---|
| GZ190703/001-Q01N01GZ99 | After test, the sample no external physical damage. |

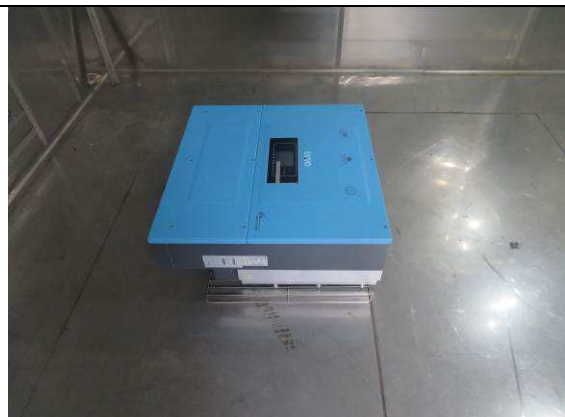
| <p>Test setup</p> | <p>During test</p> |
